Wayne County Community College District

Eastern Campus Foundation Structural

Rehabilitation

Project Title
WCCCD EASTERN CAMPUS FOUNDATION STRUCTURAL REHABILITATION

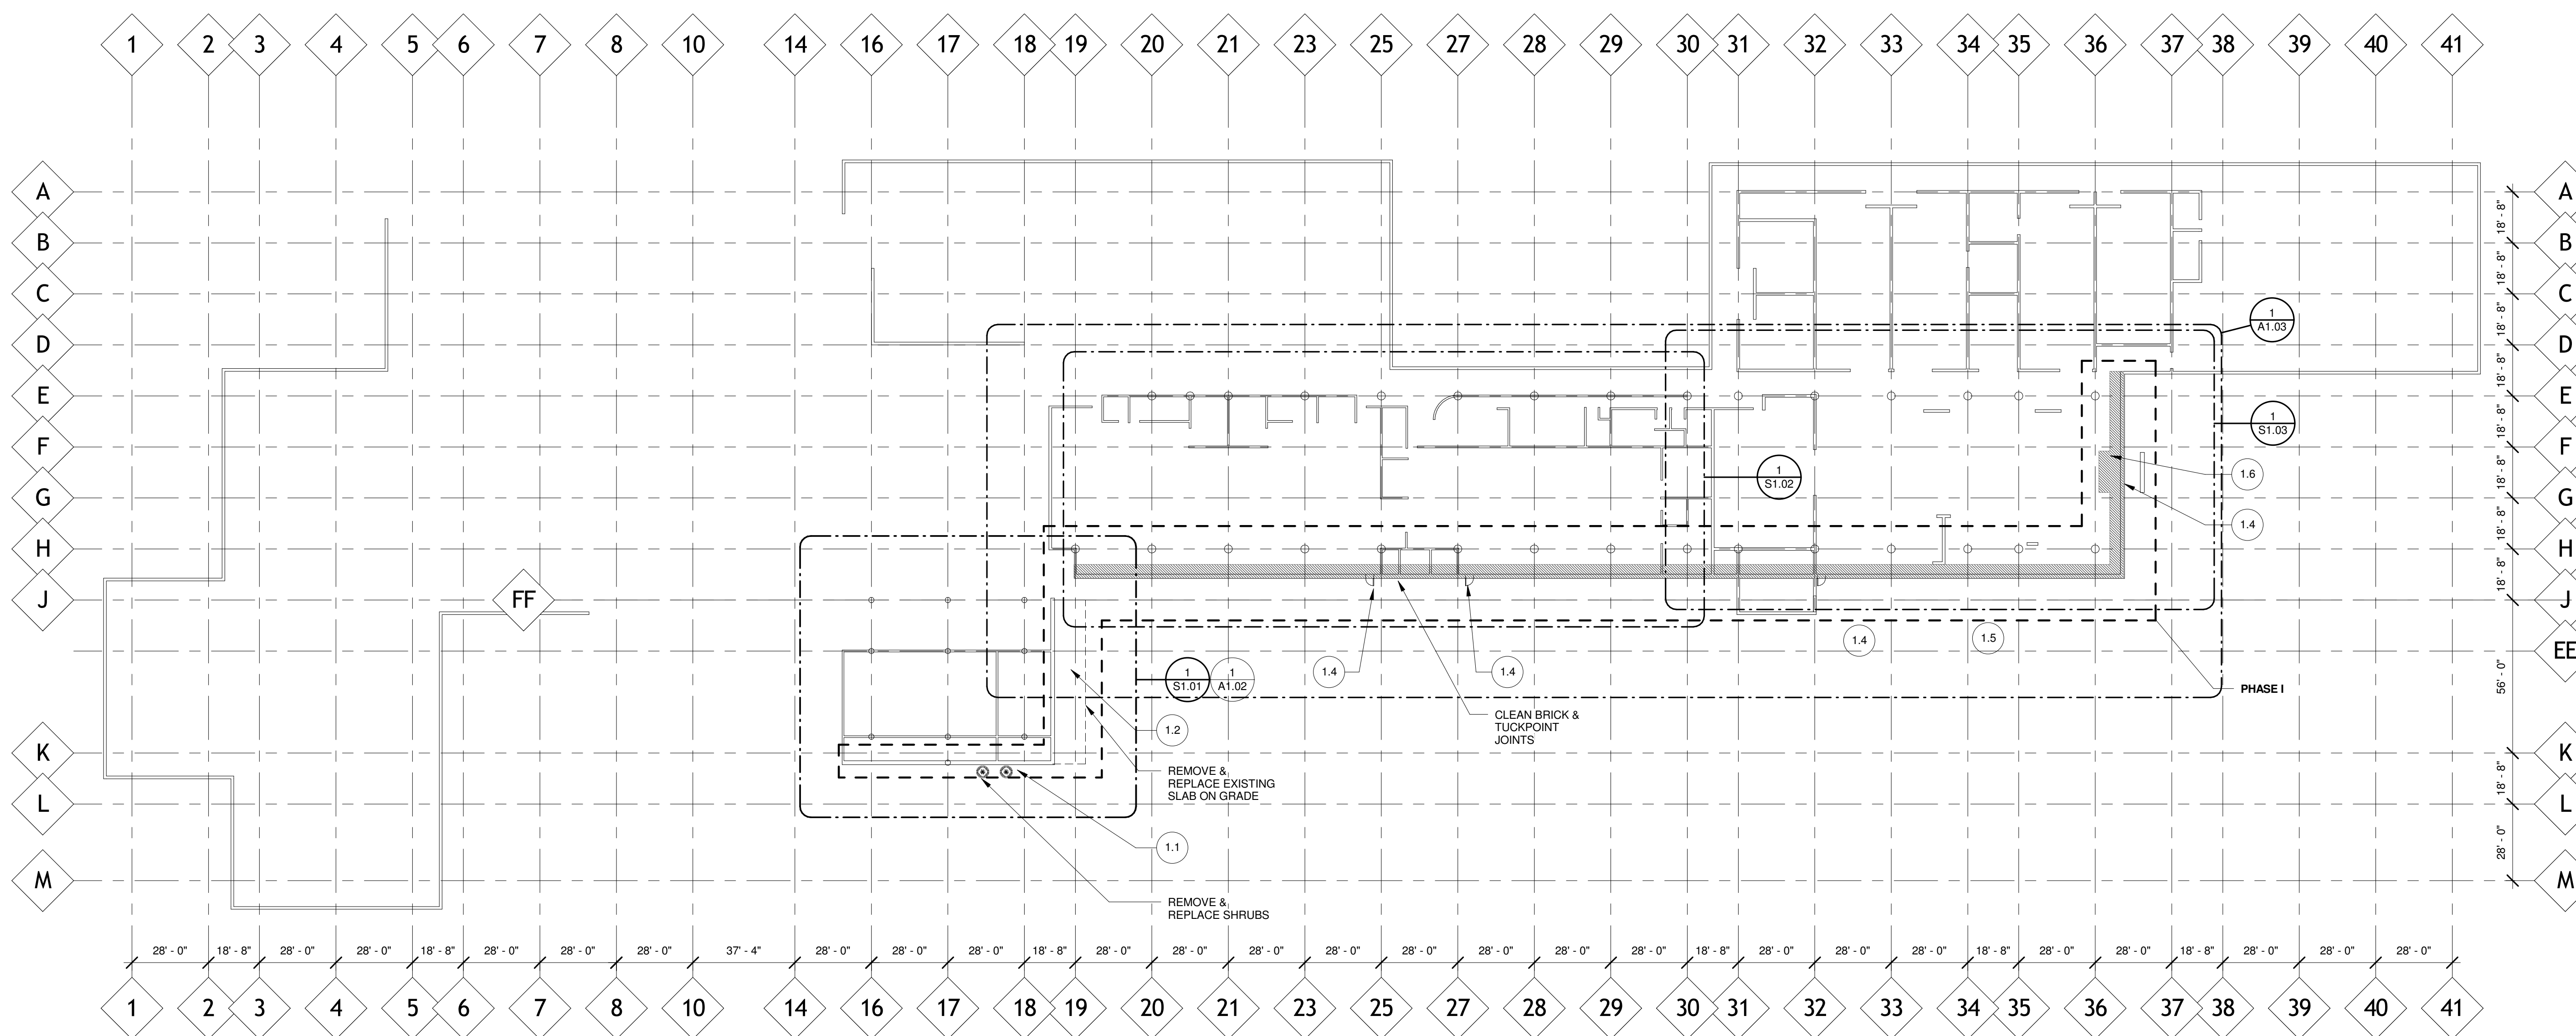
FOUNDATION PLAN-COMPOSITE
SCALE: 1/32" = 1'-0"

FOUNDATION WORK ITEM NOTES

- 1.1 REMOVE & REPLACE SHRUB AS REQUIRED TO DRILL CAISSON AT COLUMN LINE 18.
- 1.2 REMOVE AND REPLACE 6" CONCRETE PAVEMENT. PROVIDE 8" OF STONE BACKFILL. MINIMUM STONE SIZE 3" x 4" OF MDOT 21AA COMPACTED TO 95% MOIST CONTENT.

- 1.3 NOT USED
- 1.4 REMOVE AND REPLACE HOLLOW METAL DOOR AND FRAME BETWEEN COLUMN LINES 27 & 28, 32 & 33. PAINT TO MATCH EXISTING COLOR.
- 1.5 SAWCUT AND DEMOLISH 5'-0" OF EXISTING INTERIOR SLAB ON GRADE FOR PROPOSED FOUNDATION IMPROVEMENT. UPON COMPLETION, PLACE NEW CONCRETE SLAB ON GRADE.

- 1.6 SAWCUT AND DEMO 6'-0" x 18'-6" EXISTING SLAB ON GRADE. PLACE NEW SLAB TO ENSURE THE EXTERIOR HOLLOW METAL DOOR OPENS FREELY. SLOPE SLAB TOWARDS BUILDING EXTERIOR.

- 1.9 a. CONTRACTOR SHALL SHUT ALL ELECTRICAL AND MECHANICAL SYSTEMS.
b. CONTRACTOR SHALL PROVIDE TEMPORARY PIPE SUPPORTS FOR ALL ELECTRICAL & MECHANICAL PIPE BETWEEN COLUMN LINES 25 & 27. REVIEW EXISTING DOCUMENT. BEFORE WORK COMMENCEMENT, DETACH ALL PIPES FROM CMU WALLS. ATTACH THEM TO THE TEMPORARY PIPE SUPPORTS.

c. DEMOLISH ALL EXISTING CMU WALLS AND THE THICKEN SLAB UNDERNEATH. PROVIDE NEW FOUNDATION, BEAM FOUNDATION.
- 1.10 DEMOLISH AND REMOVE EXISTING SLAB, INTERIOR CMU WALL AND FOUNDATION. PROVIDE NEW FOUNDATIONS, SLAB AND CMU WALLS.

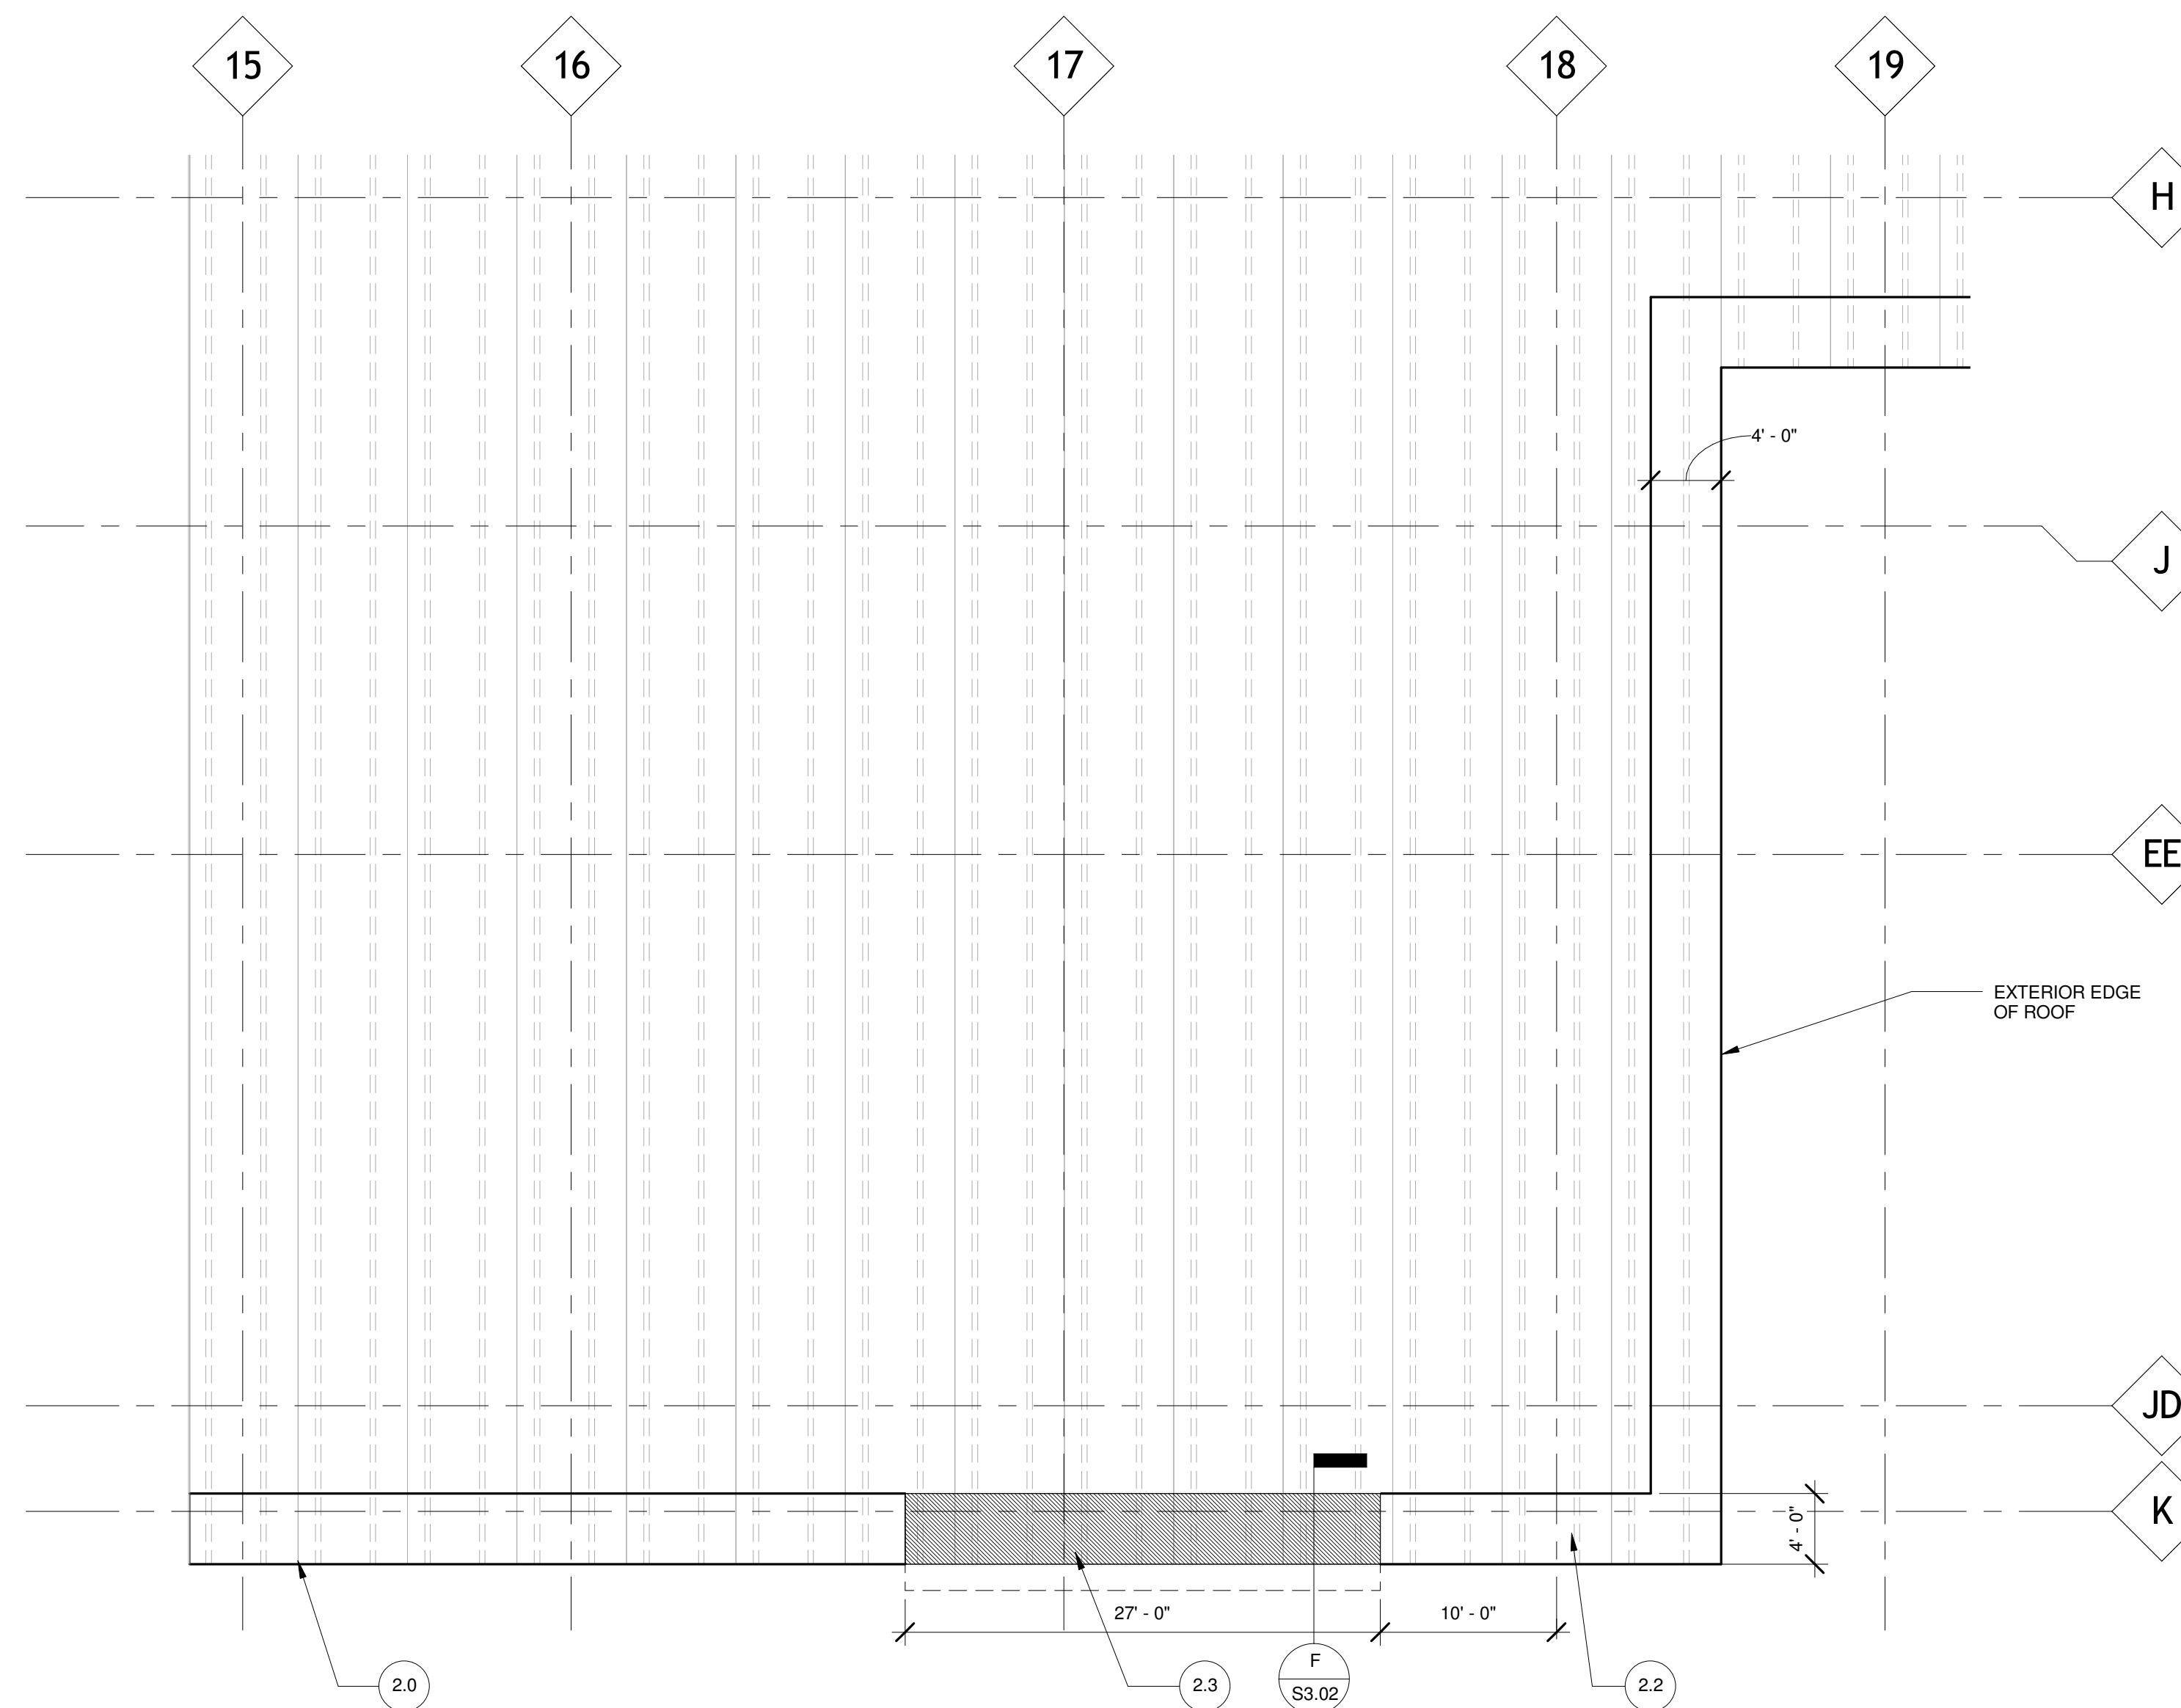
1
S1.04 ENLARGED ROOF PLAN- AREA C
SCALE: 1/8" = 1'-0"

- CONTRACTOR SHALL PROVIDE UNIT PRICES FOR REPAIR OF PRECAST CONCRETE FLANGES WITH PARTIAL DEPTH REPAIR AND FULL DEPTH REPAIR. (SEE PROJECT SPECIFICATIONS)
- CONTRACTOR SHALL FOLLOW THE METHODOLOGY PER DETAILS D & E/S3.02
- THE CONTRACTOR SHALL NOTIFY THE ENGINEER DURING THE ROOF INSPECTION. THE ENGINEER AND CONTRACTOR SHALL JOINTLY AGREE TO THE QUANTITY OF CONCRETE SPALLING TO BE REPAIRED.
- UPON COMPLETION OF FLANGE REPAIR, THE CONTRACTOR SHALL INSTALL NEW EPDM SECURELY TO PRECAST CONCRETE FLANGE AND PARAPET WALL AND ITS COMPLETE SET AND DRIED PLACE AND SPREAD THE STONE ALONG THE OUTER EDGE OF THE ROOF.

- REMOVE AND REPLACE EXISTING STAINED GYPSUM BOARD ABOVE EXISTING EXTERIOR WINDOWS, EXISTING FRAMING TO REMAIN, PAINT WHITE TO MATCH EXISTING PAINT.
 - IF CONCRETE SPALLING IS CONFINED TO SURFACE OF DOUBLE TEE FLANGE, USE DETAIL E/S3.02 FOR REPAIRS.
 - REMOVE 4'-0" WIDTH OF EXISTING STONE ALONG THE OUTER EDGE OF ROOF DOUBLE TEE FLANGE, TAKE OUT 5'-0" OF EPDM ROOF MEMBRANE TO INSPECT THE DOUBLE TEE PRECAST CONCRETE BEAMS, TO IDENTIFY CONCRETE SPALLING, CRACKS AND DELAMINATION.
 - IF CONCRETE SPALLING HAS PENETRATED THE DOUBLE TEE FLANGE AND IT IS OBSERVED FROM THE GROUND FLOOR LOOKING AT THE CEILING, USE DETAIL D/S3.02 FOR REPAIRS.
- CONTRACTOR SHALL INSPECT ALL BUILDING EXPANSION JOINTS FOR LEAKS AND REPAIR THE EPDM MEMBRANE AS REQUIRED.

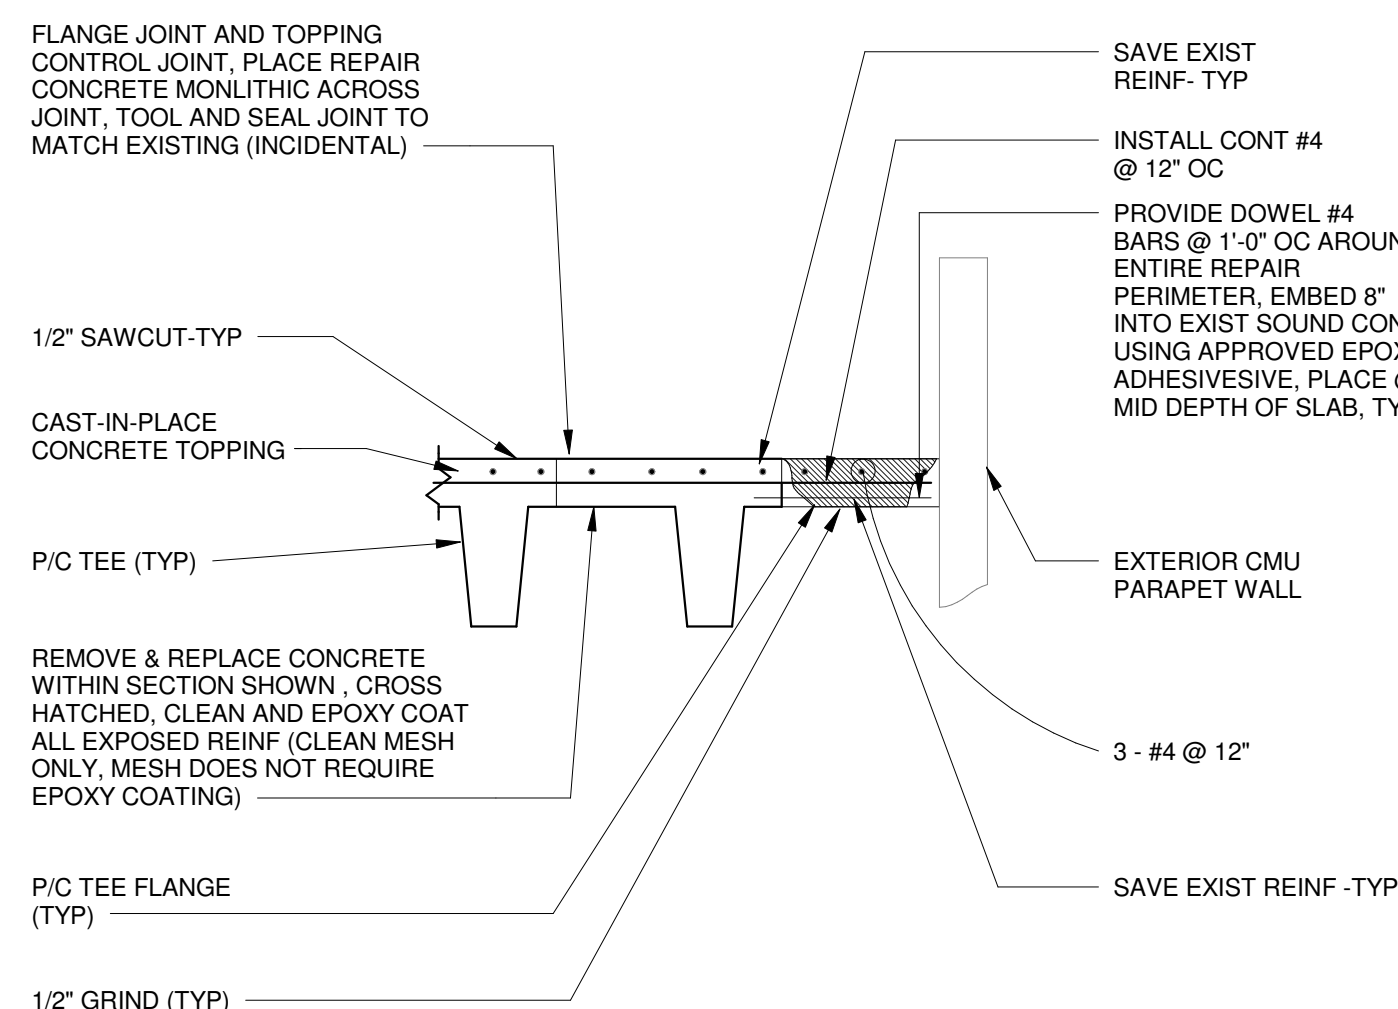
F REPAIR - FULL DEPTH
3/4" = 1'-0"

- NOTES:**
1. PROVIDE 1 1/2" COVER OVER ALL REINFORCEMENT
 2. REINFORCING STEEL INSTALLATION REQUIRED ON THIS DETAIL IS INCIDENTAL TO THIS WORK ITEM.
 3. MINIMUM LAP SPLICE FOR #4 BARS IS 20"
 4. CAUTION: FLOOR SLABS MAY CONTAIN EMBEDDED ELECTRICAL CONDUIT. LOCATE PRIOR TO START OF WORK AND PERFORM REMOVALS IN A MANNER TO NOT DAMAGE. COORDINATE REPAIR W/OWNER, AND REMOVE ONLY IF ABANDONED. EXTERNALLY-MOUNTED CONDUIT MAY OCCUR ON CEILING SURFACE.
 5. PERFORM FULL DEPTH REMOVALS TO MAINTAIN AN INWARD ANGLE AROUND THE REPAIR PERIMETER AS SHOWN.

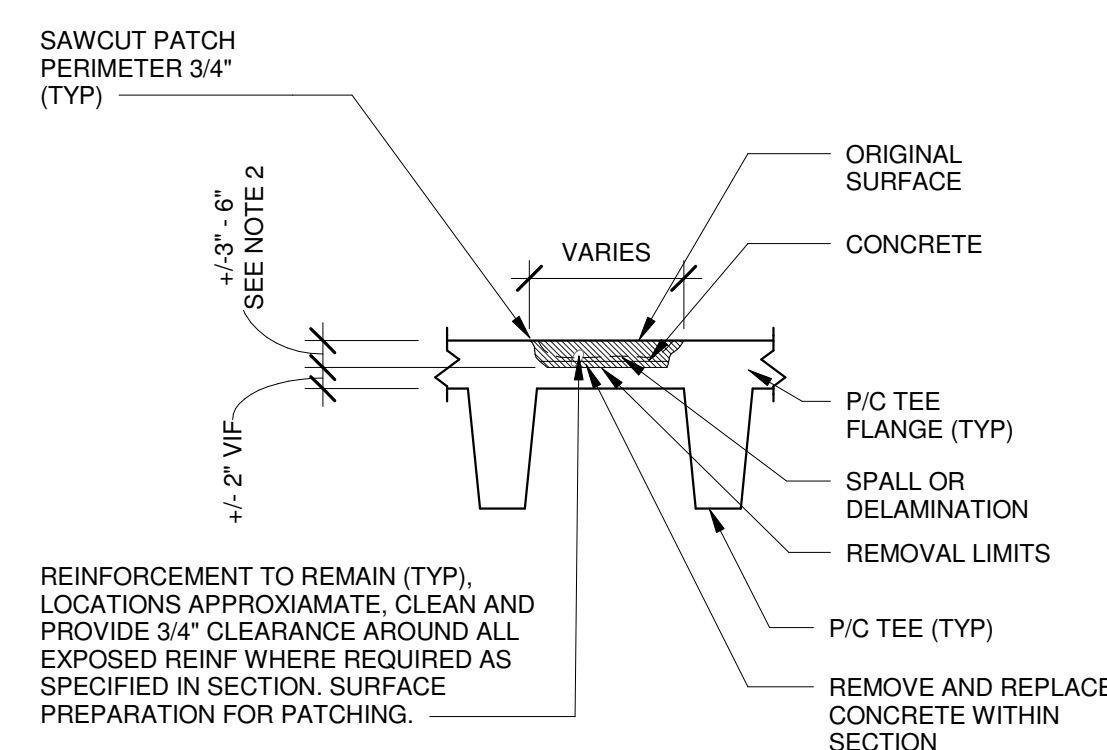
E REPAIR - PARTIAL DEPTH
3/4" = 1'-0"

- NOTES:**
1. PROVIDE TOOLED JOINTS IN REPAIR AREAS AS REQUIRED TO MAINTAIN EXISTING JOINT LAYOUT (INCIDENTAL) INSTALL JOINT SEALANT PER OTHER WORK ITEMS.
 2. ACTUAL DEPTH OF REQUIRED REMOVALS VARIES. CONTRACTOR RESPONSIBLE FOR REMOVAL DEPTHS UP TO 8" (AS SHOWN), INCLUDE IN SUBMITTED UNIT PRICE; NO EXTRAS ALLOWED.
 3. JUNCTION BOXES MAY BE PRESENT IN TOPPING CONCRETE, LOCATE PRIOR TO START OF WORK AND PERFORM REMOVALS IN MANNER TO NOT DAMAGE EMBEDDED CONDUIT.

SEE DETAIL "E" ON S3.01 FOR DOUBLE TEE FLANGE REPAIR DETAILS, THE CONTRACTOR SHALL FIELD INSPECT & INVESTIGATE TO DETERMINE THE EXACT LOCATIONS & NUMBER OF TEES REQUIRING REPAIRS

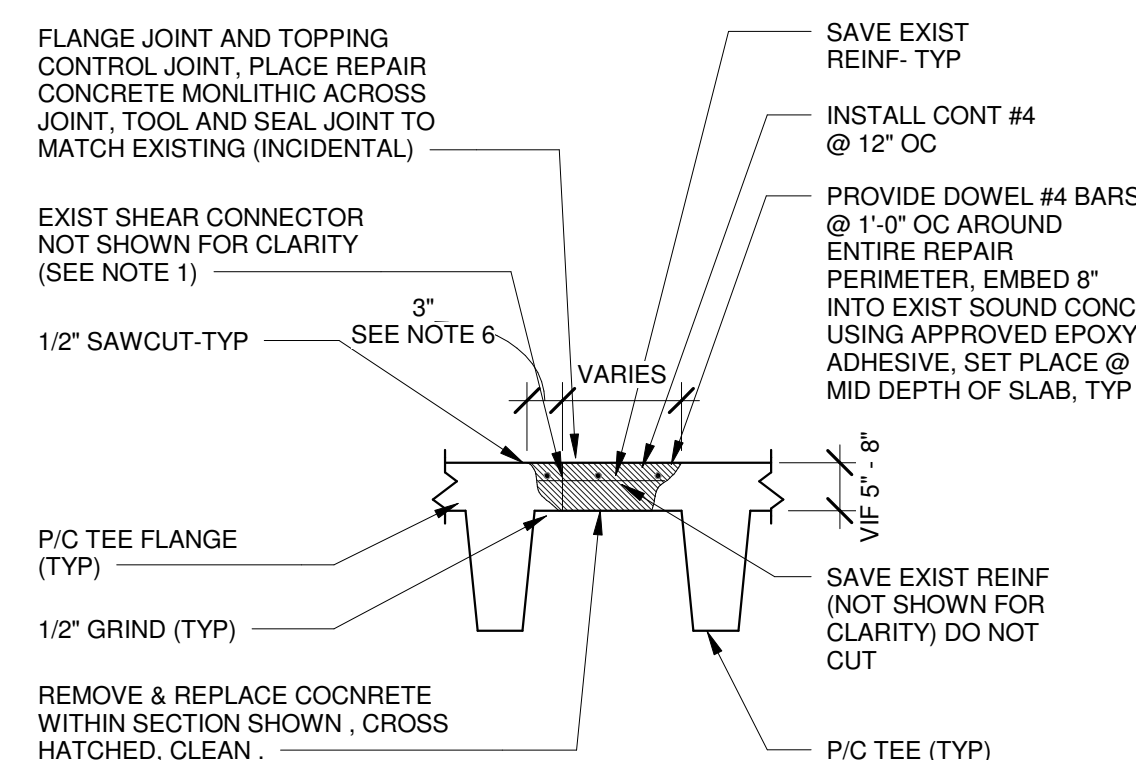
D REPAIR - FULL DEPTH
3/4" = 1'-0"

- NOTES:**
1. SANDBLAST AND EPOXY COAT ALL BROKEN TEE FLANGE SHEAR CONNECTION (OR REMOVE) AND EPOXY ANCHOR (2) ADDITIONAL #4 X 3'-0" LONG ACROSS JOINT @ MID-DEPTH AS DIRECTED BY ENGINEER (INCIDENTAL)
 2. PROVIDE 1 1/2" COVER OVER ALL REINFORCEMENT
 3. REINFORCING STEEL INSTALLATION REQUIRED ON THIS DETAIL IS INCIDENTAL TO THIS WORK ITEM.
 4. MINIMUM LAP SPLICE FOR #4 BARS IS 20"
 5. CAUTION: FLOOR SLABS MAY CONTAIN EMBEDDED ELECTRICAL CONDUIT. LOCATE PRIOR TO START OF WORK AND PERFORM REMOVALS IN A MANNER TO NOT DAMAGE. COORDINATE REPAIR W/OWNER, AND REMOVE ONLY IF ABANDONED. EXTERNALLY-MOUNTED CONDUIT MAY OCCUR ON CEILING SURFACE.
 6. PERFORM FULL DEPTH REMOVALS TO MAINTAIN AN INWARD ANGLE AROUND THE REPAIR PERIMETER AS SHOWN.

SEE DETAIL "D" ON S3.01 FOR REPAIRS OF SPALLING TEES

- REMOVE AND REPLACE EXISTING STAINED GYPSUM BOARD ABOVE EXISTING EXTERIOR WINDOWS, EXISTING FRAMING TO REMAIN. PAINT WHITE TO MATCH EXISTING PAINT.
- IF CONCRETE SPALLING IS CONFINED TO SURFACE OF DOUBLE TEE FLANGE, USE DETAIL E/S3.02 FOR REPAIRS.
- REMOVE 4'-0" WIDTH OF EXISTING STONE ALONG THE OUTER EDGE OF ROOF DOUBLE TEE FLANGE, TAKE OUT 5'-0" OF EPDM ROOF MEMBRANE TO INSPECT THE DOUBLE TEE PRECAST CONCRETE BEAMS, TO IDENTIFY CONCRETE SPALLING, CRACKS AND DELAMINATION.
- IF CONCRETE SPALLING HAS PENETRATED THE DOUBLE TEE FLANGE AND IT IS OBSERVED FROM THE GROUND FLOOR LOOKING AT THE CEILING, USE DETAIL D/S3.02 FOR REPAIRS.
